Energy-dispersive X-ray spectroscopic investigation of a fractured non-submerged dental implant associated with abutment fracture

Abstract (J Korean Assoc Oral Maxillofac Surg 2023;49:43-48)

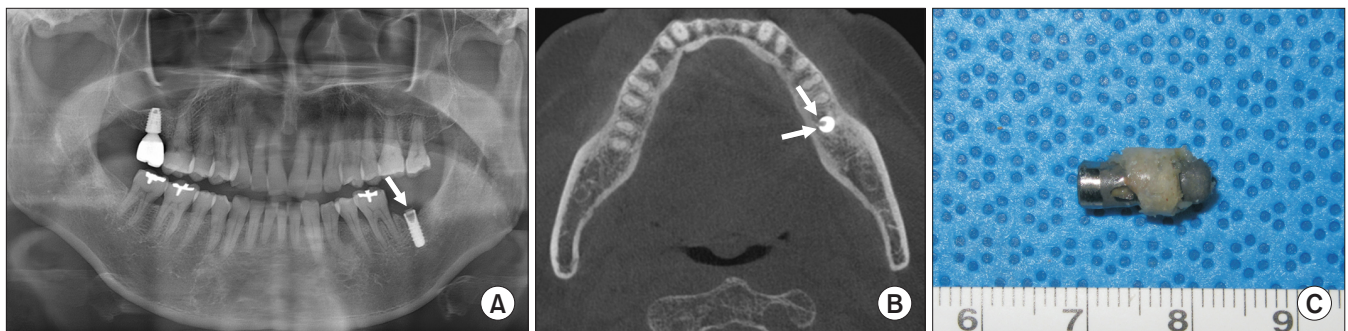
fixture. The 4.8 mm \times 10 mm tissue level, internal connection Straumann implant (Straumann, Basel, Switzerland) was placed at the local clinic in August 2010. After the implant was in function for almost 10 years, in January 2020, the patient visited the local clinic because the crown had detached from the fixture. During re-attachment of the crown, the screw was fractured. The local clinic dentist attempted to remove the screw but failed. Therefore, the dentist referred the patient to the SNUDH. From the Prosthodontic Department, the patient was referred to the Oral and Maxillofacial Surgery Department since removal of the fixture was too difficult to perform through a non-surgical approach. The panoramic radiograph revealed that the fixture of the implant was fractured at the alveolar bone level, with radiolucency at the coronal portion of the fixture.(Fig. 1. A) Furthermore, the computed tomography (CT) revealed a crevice on the mesiolingual aspect of the fixture, indicating the location of the fracture.(Fig. 1. B)

Fig. 1. Abutment of the implant was fractured at the same height level as the surrounding alveolar bone. A. A radiolucency was observed on the coronal portion of the fixture, indicating that the fixture body also was fractured (arrow). B. Axial computed tomography showed the location of the fracture at the mesiolingual aspect of the fixture body (arrows). C. The #37i fixture was retrieved with bony attachments after removal using a trephine bur.

Informed consent was obtained from the patient. Under local anesthesia using lidocaine 2% with 1:100,000 epinephrine, the implant removal procedure was performed. A trephine bur (Shinhung, Seoul, Korea) with inner diameter 5.0 mm and length 15.0 mm was selected based on the fixture diameter so that the inner diameter of the trephine bur slightly exceeded the outer diameter of the fixture. Following this selection, the trephine bur was placed over the fixture and sunk into the bone to the exact depth using low speed at 80 rpm along with copious irrigation to avoid overheating. After the trephine bur reached a depth of 80% of the fixture body, the drilling was stopped, and the trephine bur and fixture were luxated out of the socket.(Fig. 1. C) The socket was grafted using 0.5 g allogeneic particulate graft Oragraft (LifeNet Health, Virginia Beach, VA, USA) and sutured. Five months following the

surgery, a 5.0 mm×10.0 mm TSIII Osstem fixture (Osstem Implant, Busan, Korea) was installed in the grafted socket site followed by prosthetic delivery five months later.

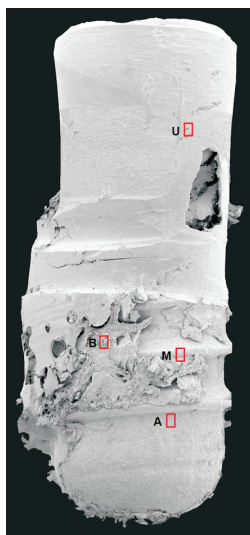
Fig. 2. Scanning electron microscopy photograph of the failed implant at ×65 magnification. The regions of interest examined by energy dispersive X-ray spectroscopy at ×10,000 magnifications are marked with red rectangles. U: surface in the upper area of the fixture, adjacent to the fracture region, M: implant surface at the middle of the implant fixture, B: attached bone tissue in the middle region of the fixture, A: implant surface in the apical region of the implant.

The SEM-EDS analysis suggested mechanical failure of the implant.(Fig. 3, Table 1) In the area near the broken region of the fixture, microfracture lines were detected.(Fig. 2; U) EDS analysis of this region showed a homogenous oxidized titanium surface (titanium [Ti]: 82.41%, oxygen [O]: 12.04%). Minor levels of carbon (C: 3.98%) and silicon (Si: 1.57%) were recorded. Particles containing C and Si were observed in the elemental distribution map. There was no detection of other metal and non-metal elements in this area.

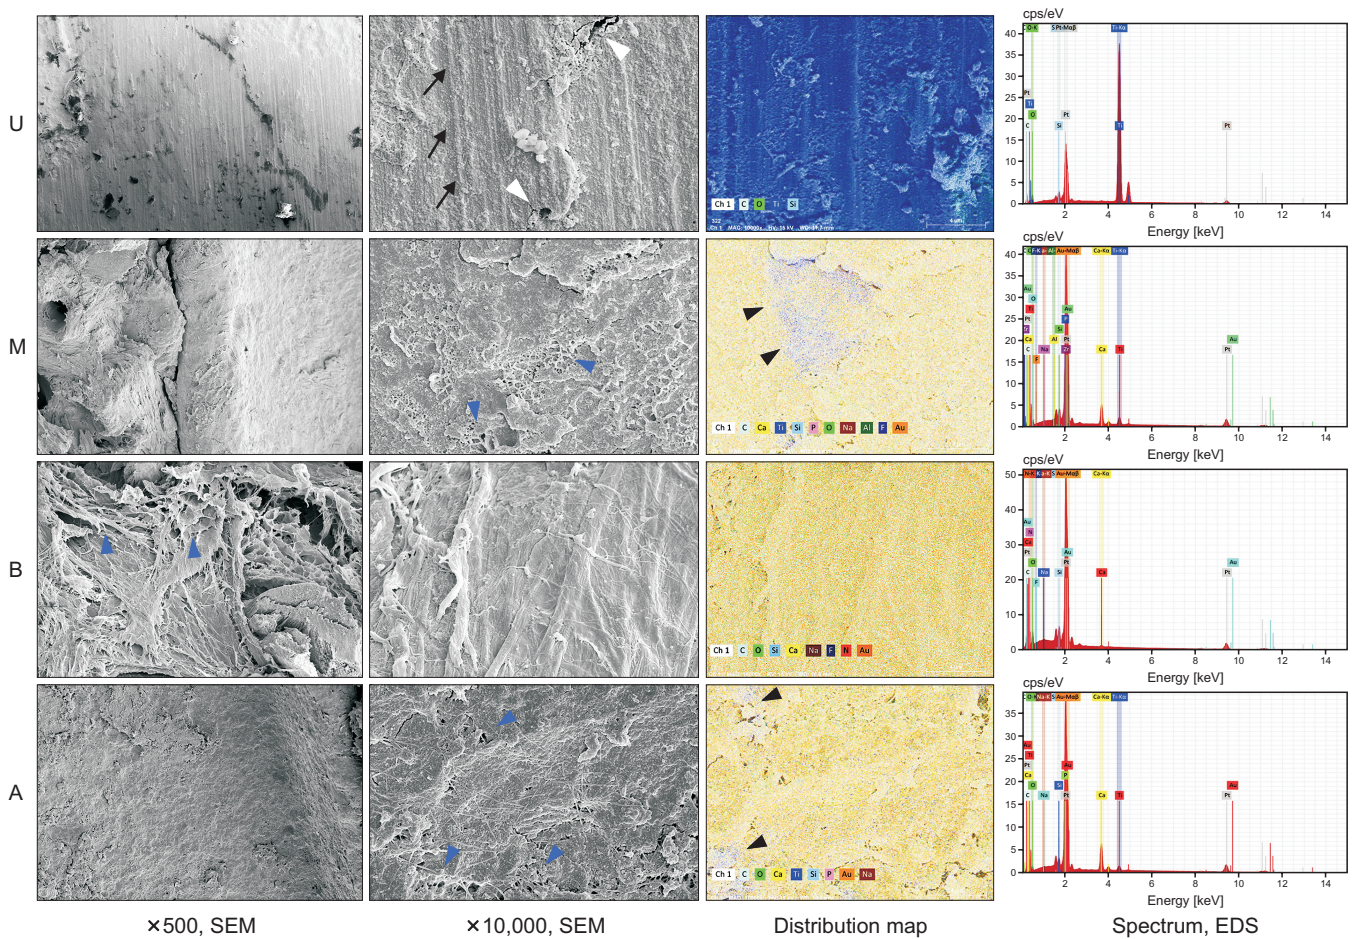
Morphologic SEM analysis of the layer of integrated bone tissue on the implant surface revealed a normal pattern with detection of bone lacunae.(Fig. 3; M, A) Both regions exhibited high levels of Ca and P (in 0102-M: Ca=23.23%, P=12.77%, in 0104-A: Ca=31.08%, P=15.70%). The Ca/P ratio of these bone regions was in the normal range: 1.82 at M and 1.98 at A. At the M point, a significantly high signal of gold (Au) was detected (10.99%). In addition, minor signs of Si and fluorine (F) and traces of sodium (Na) and aluminum (Al) were recorded. In A, the same high level of gold was detected (10.94%). Minor signs of Na and traces of Si also were recorded. Some irregular bone structures with a high percentage of organic matter was observed.(Fig. 3; 0102-B) High levels of C (30.10%), O (24.00%), and N (10.68%), and a low level of Ca confirmed the presence of organic matter over the bone surface. Noticeably, Au was detected at a pretty high level in this attached bone on the middle of the fixture (16.12%).

Fig. 3. Scanning electron microscopy-energy dispersive X-ray spectroscopy (SEM-EDS) analysis of the failed implant. SEM micrograph at $\times 500$ and $\times 10,000$ magnifications, EDS elemental distribution map, and spectrum of representative points on the failed implants. U: microfracture (white arrowheads) and scratching lines (black arrows) are observed. The elemental distribution map showed a homogeneous oxidized Ti surface with particles composed of C and Si. M: normal bone structure with bony lacunae covering the fixture surface (blue arrowheads). The Ti surface was detected on EDS in the region with a thin bone layer (black arrowheads). B: SEM images showing irregular bone structure with the presence of organic matter (blue arrowheads). EDS results reveal the presence of Na, F, N, Si, and Au. A: normal bone structure with lacunae covering the fixture surface (blue arrowheads). Trace amounts of Ti can be observed in the elemental distribution map (black arrowheads). (cps/eV: count per second per electron-volt)

The SEM-EDS results revealed an image of a fractured fixture with both normal and irregular bone patterns. Microfractures and scratching lines were observed in the adjacent area of the broken area of the fixture, indicating a fatigue condition of the fixture, which might have been caused by screw loosening and its movement during function over a long period of time. The elemental distribution map revealed a homogeneous oxidized Ti surface with particles composed of C and Si. Most of the integrated bone layer on the fixture surface was of normal bone structure with bone lacunae. However, irregular bone structure with the presence of organic matter also was detected. In addition to major elements, there was the detection of metal and non-metal elements including N, Na, F, Si, Al, and Au. The C, N, and Si were suggested to
