Cone-beam CT diagnosis of cosmetic filler-induced bone resorption mimicking a cyst: A case report

미용필러에 의한 골흡수 콘빔CT 진단: 악골낭으로 오인된 증례

Won-Jeong Han

Department of Oral and Maxillofacial Radiology, College of Dentistry, Dankook University, Cheonan, Korea

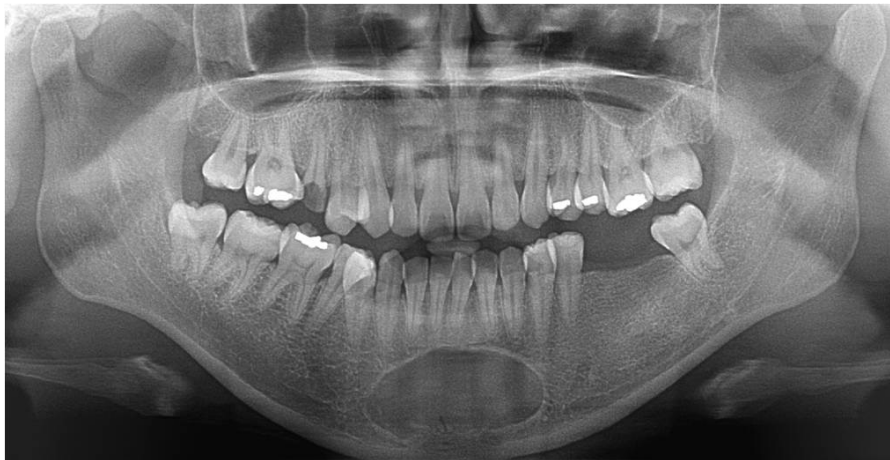
Fig. 1. Panoramic view. A well-defined, corticated, oval-shaped radiolucency was observed in the periapical region of the mandibular right to left first premolars on panoramic radiography.

32세 여성 환자의 파노라마방사선영상에서 하악 전치부 낭이 관찰되어, 정확한 진단을 위하여 본원에 의뢰되었다. 특별한 임상증상은 없었다. 파노라마방사선영상에서 하악 우측 제1소구치에서 좌측 제1소구치 치근하방에 경계가 명확하고 피

질골성 변연을 가진 타원형의 방사선투과상이 관찰되었다(Fig. 1). 방사선투과상은 해당치아들과는 무관하여 치근단낭이 배제되었고, 단순골낭의 가능성을 염두에 두고 콘빔CT 검사를 시행하였다. 콘빔CT에서 중심성 골내 병소가 아닌 악골의 순측에서 설측으로 함몰된 변연성 병소가 관찰되었다(Fig. 2). 병소의 경계는 매우 평활하였고, 단면상에서는 넓은 접시모양처럼(Fig. 3), 악골 절단면상에서는 반달모양처럼 함몰되어 있었다(Fig. 4). 설측 피질골은 비박되어 있었으나 천공은 관찰되지 않았다. 함몰된 부위는 공기가 아닌 연조직의 방사선투과상으로 채워졌으나, 콘빔CT에서는 대조도가 낮아서 연조직간의 감별이 가능하지 않았다(Fig. 5). 관찰된 턱 끝 부위의 골 함몰이 해부학적 변이인지 아닌지를 감별하기 위하여 환자의 과거 병력을 알아보았다. 환자는 2년 전에 턱 끝 부위에 미용 필러 시술을 받았다고 하였다. 방사선영상소견과 문진결과를 토대로, 미용 필러와 관련된 골흡수를 의심하였다. 이후 외과적으로 미용 필러 제거와 함몰된 부위에 골이식이 시행되었다. 수술 중에 육안으로 남아있는 미용 필러와 작은 석회화 물질들이 확인되었다. 수술 후 생검에서 다핵거대세포와 결절석회화가 관

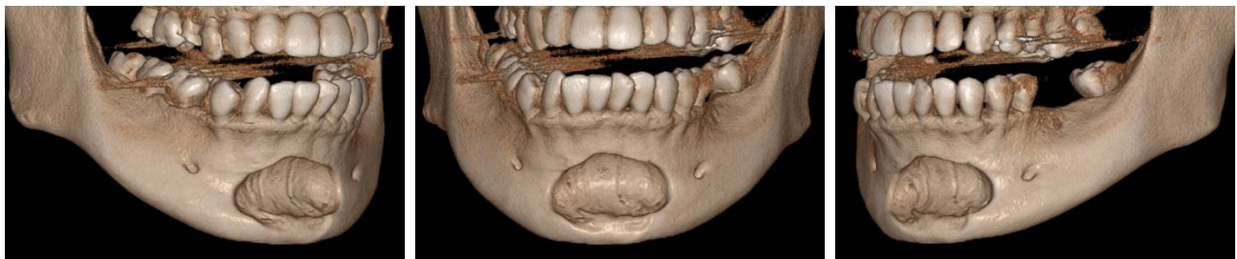
Fig. 2. Cone-beam computed tomographic 3-dimensional reconstruction image. A peripheral bone defect is observed extending from the labial to the lingual aspect of the mandible, rather than a centrally located intraosseous lesion.
