# Intra-sinus rigid fixation of a resorbable barrier membrane to repair a large perforation of the sinus membrane: a technical note

**Abstract** (J Korean Assoc Oral Maxillofac Surg 2023;49:297-303)

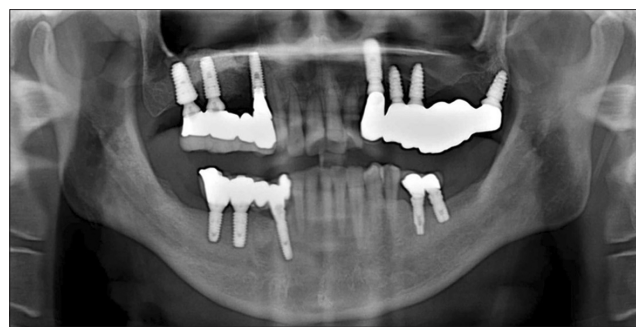
**Fig. 7.** Panoramic radiograph obtained after delivery of the final restoration.

After 6 months, the implants were uncovered, and healing abutments were placed. The patient received temporary restorations following the progressive loading protocol. Finally, 12 months after the initial implant placement and sinus lifting procedures, the final restorations were delivered and the patient expressed satisfaction with the outcome.(Fig. 7)
