## **Rajakudakan Wat Chotikaram: From Ruins to The Reconstruction of The Grand Stupa, Wat Chedi Luang, Chiang Mai\***

The Grand Stupa is mentioned in historical text as 'Rajakudakan', which means a royal building with a multitiered superstructure. This Grand Stupa is the principal construction of Wat Chedi Luang, and marks the center of the Chiang Mai City Plan.

**Keywords:** Wat Chedi Luang, Lanna, point cloud images, heritage building information modelling, reconstruction supposition

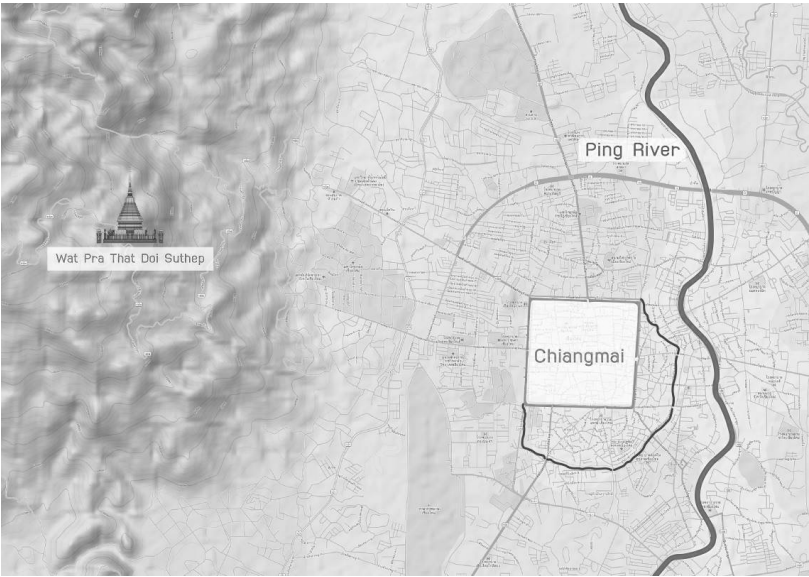
<Fig. 2> Geography of Chiang Mai City flanked by Mae Ping River in the east and the Suthep Mountain in the west

Chiang Mai City was established by King Mangrai in 1296 on the hugely abundant lowland flanked by Mae Ping River and Suthep Mountain, featuring a perfect location of an urban settlement <Fig. 2>. The city was given a convenient canal journey through Mae Ping River and the lowlands of the east, suited for the traditional irrigation of dikes and irrigation systems (Mueang Fai), which were typically invented by Tai-speaking people to divert river for farming. Considerably, this traditional irrigation contributed to the security of food and administration that Chiang Mai was able to centralize a huge group of traditional states of 'Lanna'.

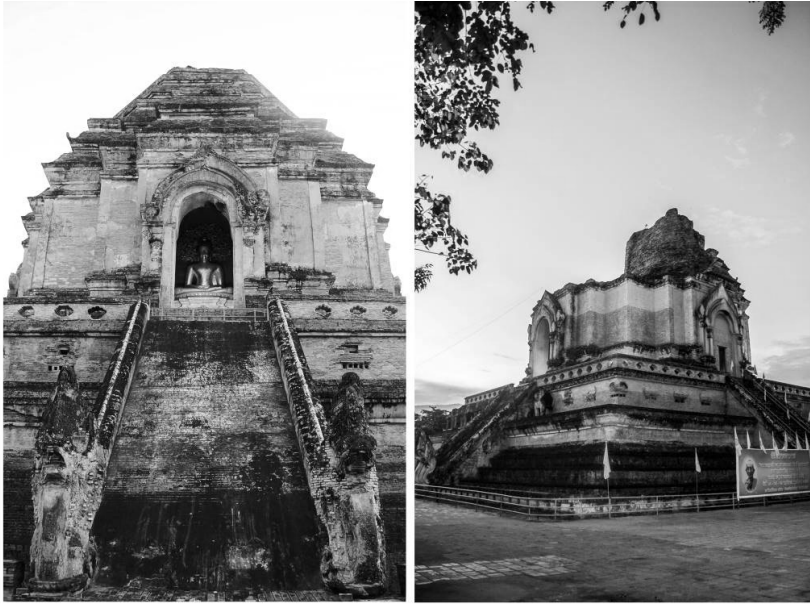
<Fig. 4> Current architectural condition of the Grand Stupa with its damaged superstructure, Wat Chedi Luang

Thereafter, in 1545, the superstructure of the Grand Stupa collapsed after an earthquake during the reign of Queen Jiraprap <Fig. 4>. Remarkably, it resulted in the irreparable damage of the Grand Stupa's superstructure since then (Ongsakul 2009: 177).
